Sensor Characteristics Attributable to Base Plate Thickness of Piezo-Composite Sensors

Nobuhiro Shimoi, Kazuhisa Nakasho, Carlos Cuadra. Sensor Characteristics Attributable to Base Plate Thickness of Piezo-Composite Sensors. *International Journal of Mechanical Engineering and Applications*. Vol. 10, No. 5, 2022, pp. 105-112. doi: 10.11648/j.ijmea.20221005.12

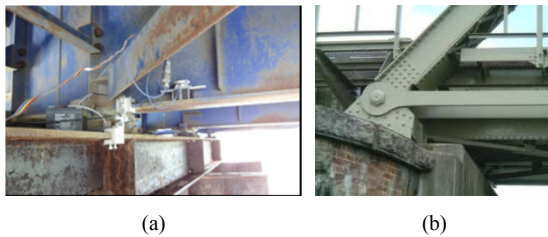
Figure 1. Assembly bridge structure.

Target bridge components are joined by fastening with bolts or by welding. Figure 1(a) portrays the welded structure. Panel (b) depicts the bolted structure.

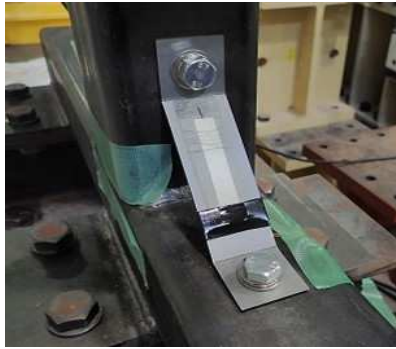
Piezo-composite sensors have been manufactured to measure voltage according to the fracture at the welded joint of the steel structure. This inexpensive sensor is disposable: it breaks during a failure measurement. Because the piezo film used is a piezoelectric element that emits electric power by itself, no power supply is necessary for measurement when a sensor is used for field measurements. For this study, after prototyping piezo-composite sensors of two types using metal plates of five thicknesses, we compared and examined the output intensities that were obtained when a force was applied to each sensor. Figure 2(a) portrays the A-type piezo-composite sensor configuration. Figure 2(b) shows the piezo-composite sensor base metal plate, made of approximately 16×73 mm piezo film (DT2-028K / L; Tokyo Electronics) and $25 \times 75 \times 1$ mm hard plate glass with an ultraviolet curable adhesive (Loctite 3851; Henkel Japan) [11]. Figure 3 shows the piezo-composite sensor attached to a welded joint of the steel T-shaped specimen.

Figure 3. Setting of piezoelectric composite sensor.
